FINAL INSPECTION REPORT		
TOTAL	PAGES: 08	DATE: 2020-05-09	- 8

Buyer: Dutch Go Netherlands	vernment	LCH in the	P.O. I	No: LCH2	20200140-02	
Control: Beconn	nghai Ltd	REFE	RENCE N	10 :		
Supplier: CHENG	DE TECHN	OLOGY CO	O .,LTD			
Manufacturer: C	HENGDE	rechnolo	GY CO .,LTD	)		
Product Description: Folding Protectiv			ive Mask			
Style/Item/ Article	Order No	Order Qty	Declared Qty	Nr. of Ctns	Color	Status
Article	NO	Qty	Qty	Cuis	1	Eta al
KN95 Mask	LCH2020 -0140-02	5.1.1c White In			Final Inspecti on	
Inspection Type: FINAL INSPECTION   Inspection Date: 2020-05-09						
Inspection Location: #888,Shiji Ave.,LongGang City,Zhejiang, China

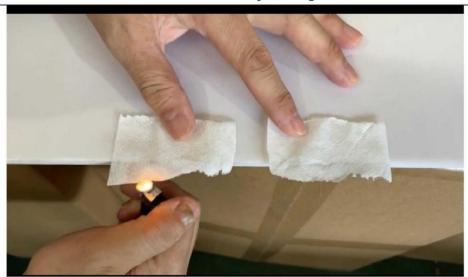
## Burning of melt blown layer – add photos

Take 'melt blown'
layer

2. Burn layer

3. See if it becomes transparent

## Also take video of burning

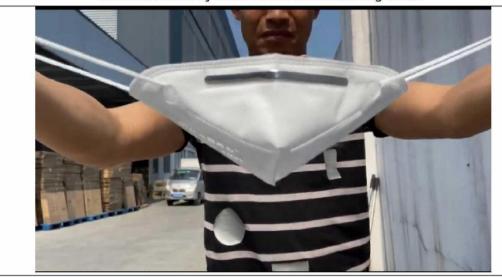
## Fluid penetration – add photos

- 1. Open mask as if
- 2. Aim inside up,
- 3. Hold 30 cm
- 4. Check if fluid

# Sample photo of mask holding water Also take video of mask 30 cm under running water

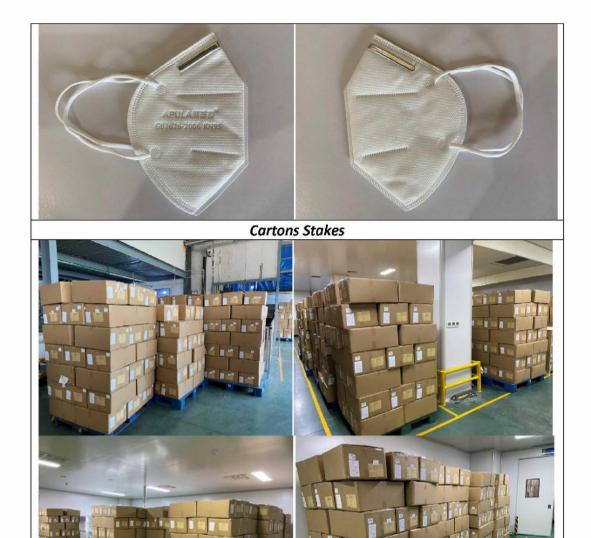
Packing & Labeling

Confirm	Dict	turo
Commi	FIC	ture
ОК	Classic Letterne (1351) (2725 300 coss (7)2.5	ALANE
	<b>Confirm</b> OK	OK

Inner packing unpacking	ОК	TENTULATION TO SET OF S
A box qty	ОК	
Carton Main Mark & Side Mark	ОК	AND SECOND SECON
Box pack	ОК	
Mask try it on	ОК	5.1.2e
